LOWER HUDSON RIVER BASIN  
ALTAMONT MAIN RESERVOIR DAM

ALBANY COUNTY, NEW YORK  
INVENTORY NO. N.Y. 126

PHASE I INSPECTION REPORT  
NATIONAL DAM SAFETY PROGRAM

PHASE I INSPECTION REPORT  
NATIONAL DAM SAFETY PROGRAM  
ALTAMONT MAIN RESERVOIR DAM  
I.D. No. NY 126

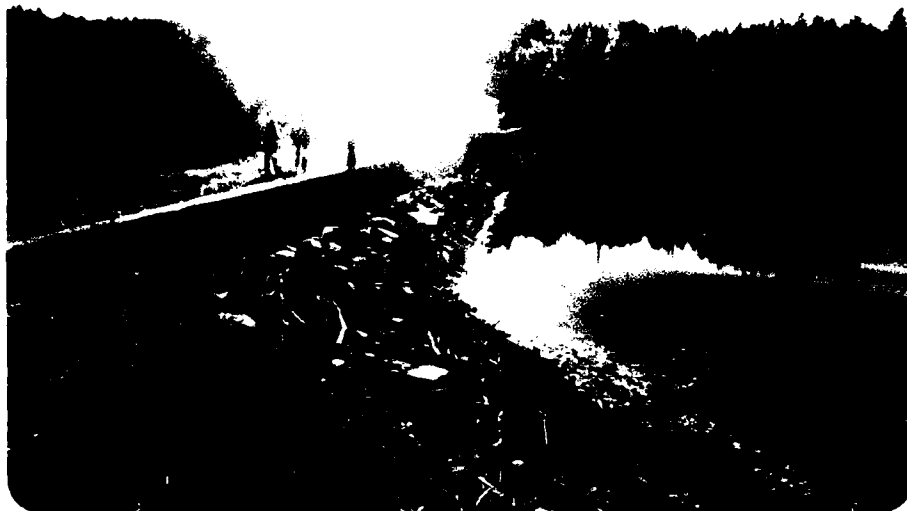
A gate house located near the midpoint of the embankment at the toe of the upstream slope controls the flow of water to the Village of Altamont. The gate house is connected to the embankment by a concrete catwalk. The concrete of the catwalk has deteriorated to the point where steel beams have been used to stiffen the walk. The water in the reservoir may be discharged through 3-8 inch valves into 2-18 inch cast iron pipes which extend beneath the embankment to the control building near the toe of the downstream slope. From the toe of the dam, an 8 inch pipe extends from the 12 inch pipe and supplies water to the Village.

Photo #2  
View of embankment and gate house.

4. Monitor the deterioration of the catwalk and repair as required, .
5. Monitor the seepage observed at the base of the spillway chute and at the reservoir drain outlet. If seepage increases significantly, investigate and repair.
6. Periodically remove the debris in the downstream channel.
7. Backfill the animal burrow noted near the crest of the embankment.
8. Remove the brush on the embankment and the downstream area beyond the toe.
9. Provide a program of periodic cutting and mowing of the embankment surfaces. Provide a program of periodic inspection and maintenance of the dam and appurtenances, including yearly operation and lubrication of all valves. Document this information for future references. Also develop an emergency action plan for the notification of downstream residents and the proper governmental authorities.
